IONE BRIDGE PLANNING REPORT

Prepared For:
Pend Oreille County Public Works Department

April 2021

Nicholls Kovich

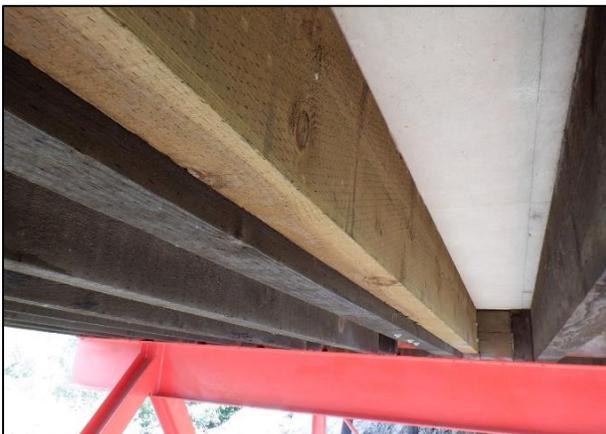
Photo 3 – Helper beam at Girder 13G

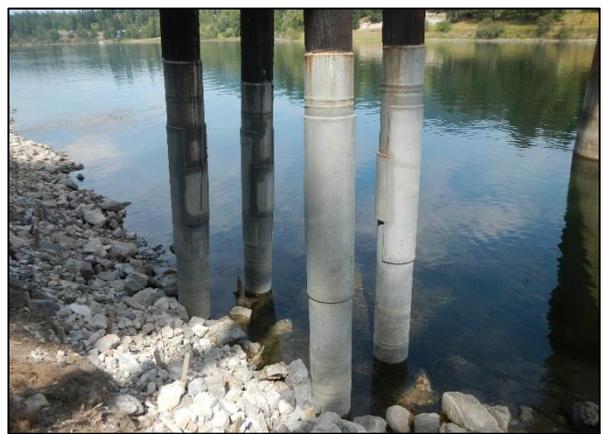
Photo 4 – Spliced timber piles at Pier 7

Six piles were repaired in the 2011 major rehabilitation project. Two piles within Pier 13 received a Fiber Reinforced Polymer (FRP) jacket and four piles within Pier 7 were spliced near the groundline due to heavy decay. Repairs made in 2011 are performing well.

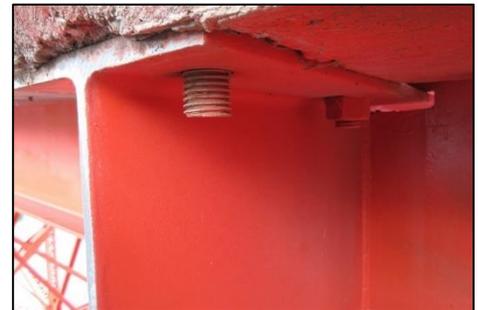
There are three locations where a 1-inch hex nut is missing from the bolt connecting the concrete curb to the steel floor beams (Photo 5). These missing nuts are located on the north side at truss points U1, U2, and U3 (Span 8). Though a relatively simple repair to install, it would require special access, such as with a UBIT or a climber. Estimated costs assume that this work can be accomplished during the next routine bridge inspection if materials are provided by the County.

Photo 5 - Missing Nut

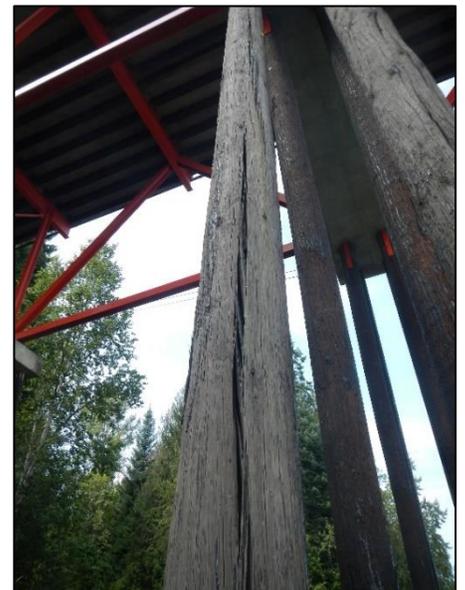
Piles with deep checking will deteriorate more quickly as the internal portion of the piling is exposed to oxygen, organisms, and moisture. Additionally, the severe checking of piling has the potential to jeopardize the stability of the piles (buckling) if advanced section loss occurs. Also, wide checking could advance into a through split which would significantly reduce pile capacity.

An analysis of the tallest piling in the lone Bridge indicates that structural capacity will start to be affected when approximately 15% of the pile section is lost. A split through the pile would indicate a serious structural deficiency.

Photo 6 – Pile 7D up to 2-inch wide checks

Potential repairs for checking depend on severity and can range from preservative treatment to steel banding to crack filling and then pile jacketing for the most severe cases. FRP pile jackets are suitable for repairing piling that needs an increase in strength, but do not require total replacement. The space between the pile and the jacket is filled with a marine epoxy which completely fills cracks and voids. The FRP pile jacket system protects the pile from the elements and it cuts out oxygen access to the wood, thereby eliminating the potential for decay. Cost estimating in this planning report assumes twelve piles would be repaired with pile jacketing.

Prior to design and installation of permanent repairs, piles should undergo non-destructive testing for decay at multiple locations near ground level. If any decay is found, pile splicing may be required to eliminate any unsound material. A Resistograph machine may be used.

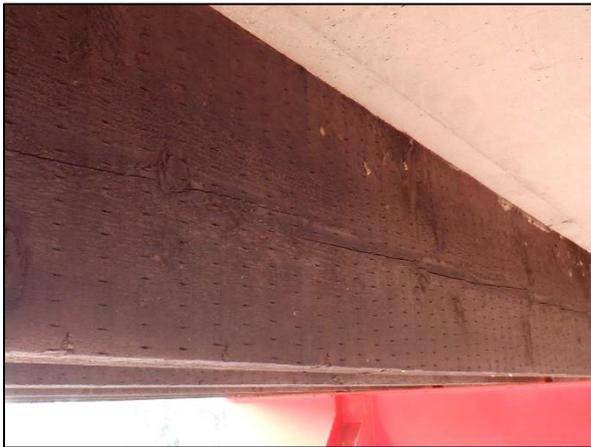
Checking in timber girders is a natural process that occurs due to separation of the wood fibers. The outer surface of the girder loses moisture to the atmosphere and begins to shrink while the interior of the girder loses moisture at a much slower rate. This differential shrinkage results in checking. Checking is not a structural concern, unless it is very severe and affects a significant portion of the girder. The checking in the timber girders of the lone Bridge is not extensive enough to be a structural concern.

Photo 7 – Heavy Checking in Girder 11H

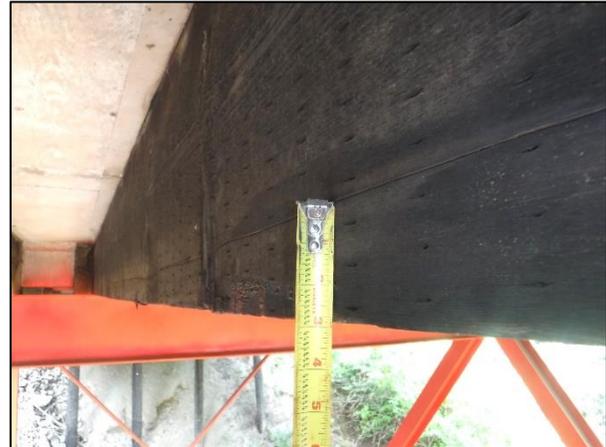
Photo 8 – Split in Girder 4I

Splitting in timber girders differs from checking in that a split extends through the member from face to face. Splits are prone to propagate and often increase with time. Splits can be caused by normal seasoning or due to a stress riser from a notch or defect in the timber. Sometimes splitting can be stress related. Severe splitting can have an effect on both the shear and flexural strength. Severe splitting can be taken as any split that exceeds 25% of the member length, according to the *Montana Timber Bridge Inspection Guide*. Therefore, it is important to repair any splitting that has become severe. A full length longitudinal split in one of the lone timber girders could reduce the flexural capacity between 10-50%.

There are presently 12 timber girders which have splitting. The splitting ranges in length from several feet to full length (19-ft). Girders which have splitting have been yellow-tagged. The Washington State Bridge Inspection Manual (WSBIM) defines this as members with structural defects which do not significantly affect structural capacity. WSBIM recommends inspecting yellow-tagged timbers at least every 12 months.

We recommend installing helper beams at the 6 timber girders which have splitting along at least half the girder length. Helper beams should be slightly shallower than the existing girders to facilitate installation. Steel shims should then be used to bring the girders into contact with the concrete deck. The helper beams should be securely attached to the existing girders with bolts at the ends.

If this repair is not performed, there is possibility that the splitting in the girders could deteriorate further, requiring a reduction to the load rating. Performing this preventative maintenance will ensure that there is reserve capacity in the compromised girders, avoiding the need to reduce the bridge's load capacity.

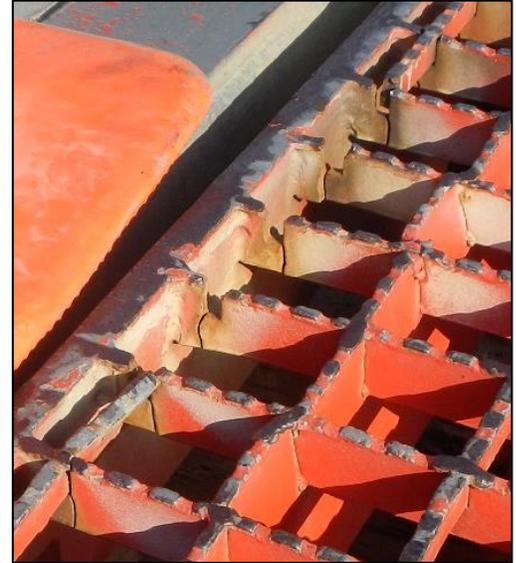
Overall the open-grid steel decking is in good condition. There are some isolated defects which include cracked bars and welds (Photo 9). Additionally, some of the bars are bent or have fractures likely from vehicle impact damage. The total area of defects in the open-grid decking is 254 square feet or 3% of the deck area. The steel decking is more prone to defects near the ends where there is an abrupt change in deck type from concrete to steel.

Photo 9 – Missing Supplemental Bars and Cracking of Cross Bars at West end.

To extend the lifespan of the existing open-grid steel deck, it is important to fix the cracked welds and bars. Any bent and fractured bars should be repaired and rewelded. Fractures propagating into the distribution bars should be arrested by welding as well.

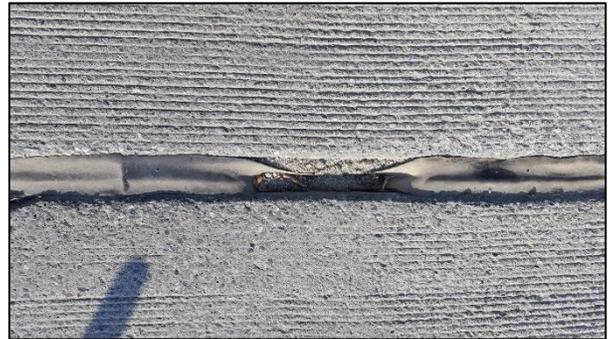
There are expansion joints at Piers 4, 5, 6, 7, 12, 13, 14. These were originally designed as compression seals in the approach spans that were added during the 1967 Reconstruction. The compression seals were replaced with rapid-cure silicone (RCS) sealant joints in 2011. However, these joints have not performed well and were noted to have issues such as debonding as early as 2015. The 2019 inspection report notes that 60-ft is debonded and 38-ft has dropped or is filled with debris. Every joint has debonding for a length between 5-ft and 17-ft. The total length of RCS sealant is 182-ft. Locations where the RCS sealant joints are debonded will allow water and debris to get down to the superstructure and substructure, potentially causing issues due to moisture.

Photo 10 – Failed Deck Joint

The currently installed type of expansion joint is the Rapid-Cure Silicone (RCS) joint. As mentioned previously, all joints at the Lone Bridge have at least some debonding. Since it is not realistic to replace just the failed portion of a joint, we recommend full replacement of all RCS joints at the Lone Bridge.

We recommend replacing the existing RCS joints with compression seals since the RCS joint system has proven to be short-lived on both the Lone and Usk bridges. Since this bridge originally had compression seal expansion joints from 1967, it is possible that the original ledge seats for compression seals still exist. If that is the case, the compression seal could be installed immediately following removal of RCS joint material with minimal prep work. This could greatly speed up the installation process as well as bring down cost. Unfortunately, the condition of the ledges and edge surfaces would not be known until the RCS joint is removed. If the ledge is damaged or the concrete surface is very rough, sawcutting may be required. The preliminary cost estimate for compression seals includes sawcutting since it may be required.

After installation of the compression seal material, we recommend applying a bead of silicone along the edges of the joints. This will help seal up any gaps due to uneven concrete surfaces.

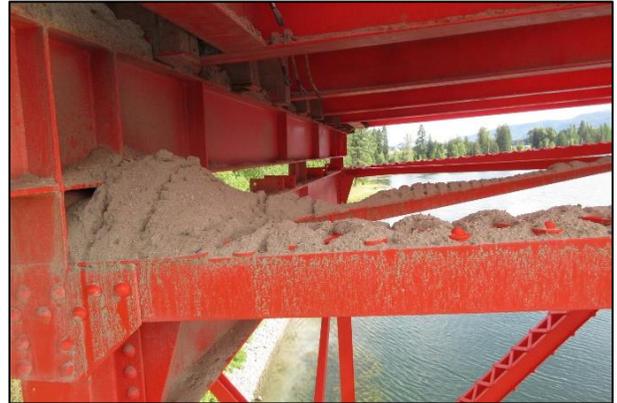
The open-grid steel decking over the main truss is a lightweight and durable deck; however, the openings in the grid do allow roadway debris to fall through and build up on bridge members (Photo 11). Debris accumulation has been a continuous maintenance concern on the lone bridge due to the openings in the steel deck portion. The majority of the debris buildup occurs at 1) the beginning and end of the open-grid decking where impact is the highest and 2) in the top chord where members are close to the deck and can “hold” debris and water due to their shape. Members which experience lengthy periods of debris and moisture exposure, especially if salts are present, could experience an accelerated rate of corrosion.

Photo 11 – Heavy debris accumulation at beginning of steel decking.

Frequency is recommended every two years (prior to the fracture critical inspection), but at least every four years if cost becomes a factor. It is our engineering opinion that based upon observed defects in the Lone Bridge, cyclical cleanings will be an important step for preventative maintenance to extend the life of the bridge.

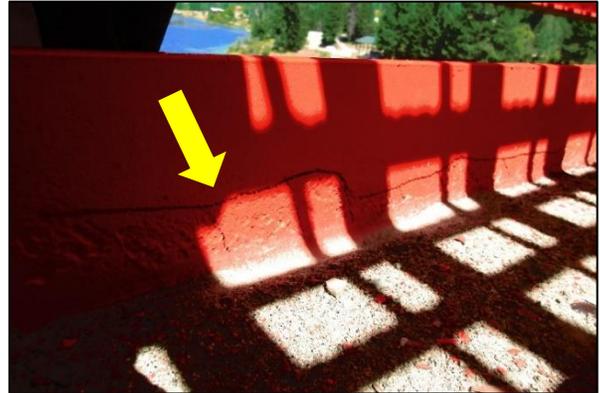
While it is not fully known the extent of corrosion in the Lone Bridge that can be attributed to debris buildup, there is evidence that debris and associated moisture is breaking down the protective paint coating and may have contributed to past pitting. Photo 12 shows an outline of pitting corrosion in the top chord of the truss in an area where debris can build up. This is of notable concern since the majority of top chord members are fracture critical and currently hold debris. If a member is covered with debris, it makes it difficult to fully inspect for defects. Therefore, it is highly recommended to pursue a regular washing program for the Lone Bridge.

Photo 12. - Pitting corrosion in top chord where debris can build up.

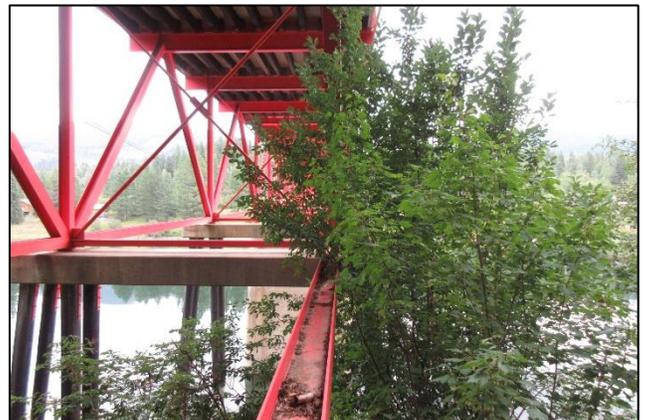
This is a straightforward maintenance item to clear out tree and brush vegetation that encroaches on the steel truss at the west end (Photo 13). This maintenance item could be performed by County crews and could be completed in one day or less. This is important step to keep moisture and debris away from painted steel members.

Photo 13 - Vegetation encroaching on truss

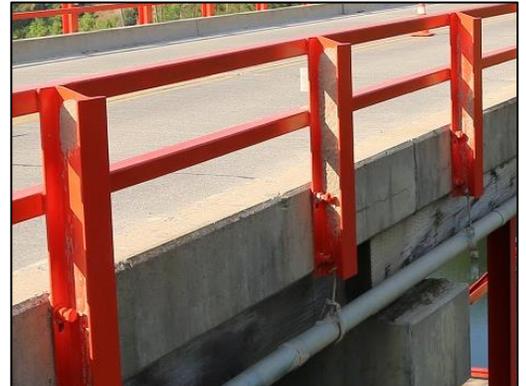
The rail at the Lone Bridge consists of 6-inch steel rail posts spaced at 6'-4" mounted on the outside edge of the concrete curbs (Photo 15). The horizontal rails consists of two 4x3 steel tubes. The rail height above the driving surface is 39.5-inches which is 2.5-inches short of the current AASHTO requirements and 14.5-inches short of the Washington State requirement. The current weight of the steel railing is 40 lbs. per linear foot.

Photo 15 - Lone Bridge Railing

Any retrofit to the bridge rail would require an increase in weight (dead load) applied to the bridge. To retrofit the bridge for bicycle requirements, the bridge rail would require both an increase in height and adding horizontal members to reduce opening size.
