IONE BRIDGE PLANNING REPORT

Prepared For:
Pend Oreille County Public Works Department

April 2021

Nicholls Kovich

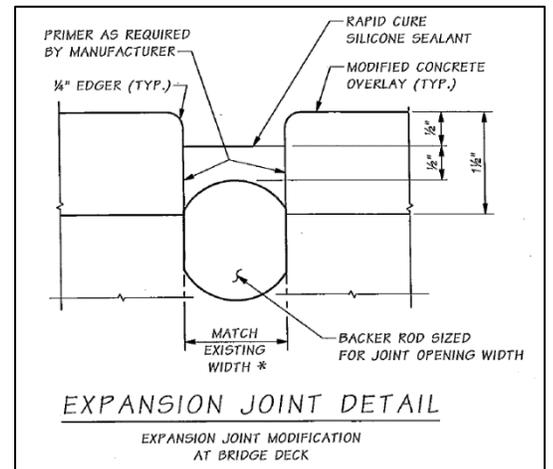
Figure 2: Rapid Cure Silicone Sealant (2011 Maintenance)

The currently installed type of expansion joint is the Rapid-Cure Silicone (RCS) joint. As mentioned previously, all joints at the Lone Bridge have at least some debonding. Since it is not realistic to replace just the failed portion of a joint, we recommend full replacement of all RCS joints at the Lone Bridge.

We recommend replacing the existing RCS joints with compression seals since the RCS joint system has proven to be short-lived on both the Lone and Usk bridges. Since this bridge originally had compression seal expansion joints from 1967, it is possible that the original ledge seats for compression seals still exist. If that is the case, the compression seal could be installed immediately following removal of RCS joint material with minimal prep work. This could greatly speed up the installation process as well as bring down cost. Unfortunately, the condition of the ledges and edge surfaces would not be known until the RCS joint is removed. If the ledge is damaged or the concrete surface is very rough, sawcutting may be required. The preliminary cost estimate for compression seals includes sawcutting since it may be required.

After installation of the compression seal material, we recommend applying a bead of silicone along the edges of the joints. This will help seal up any gaps due to uneven concrete surfaces.

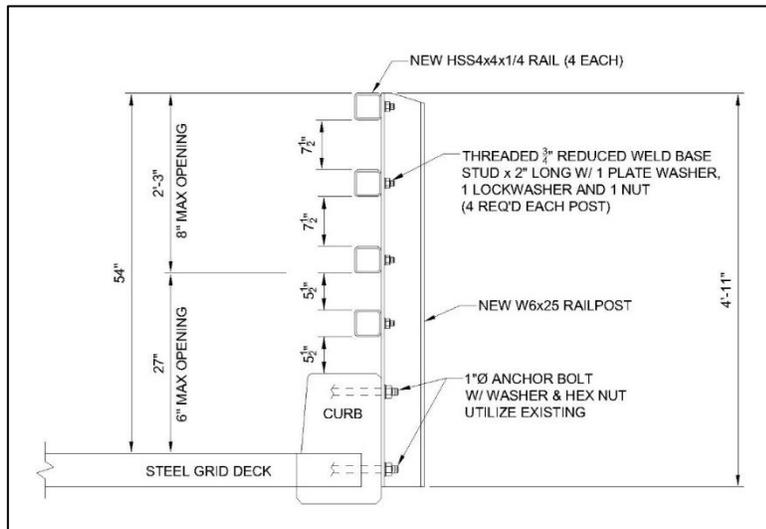
Figure 5: Rail Retrofit Detail

The rail at the Lone Bridge consists of 6-inch steel rail posts spaced at 6'-4" mounted on the outside edge of the concrete curbs (Photo 15). The horizontal rails consists of two 4x3 steel tubes. The rail height above the driving surface is 39.5-inches which is 2.5-inches short of the current AASHTO requirements and 14.5-inches short of the Washington State requirement. The current weight of the steel railing is 40 lbs. per linear foot.

Furthermore, a retrofit would require consideration of the railing's adequacy for vehicular loading. The rail at Lone is not a crash-tested system, nor does it meet any present-day railing standards. Per the WSDOT Bridge Design Manual, for systems constructed prior to the year 2000, a retrofit would need to resist a 10-kip barrier impact design load. In a review of the existing bridge rail, both the rail posts and the attachment bolts do meet the 10-kip barrier load. Therefore, a retrofit is feasible to meet both bicycle and vehicular loading for existing bridges.

For the purpose of this planning report, Nicholls Kovich Engineering reviewed several rail retrofit concepts with the recommended concept shown in Figure 5. This rail retrofit design provides for the following:

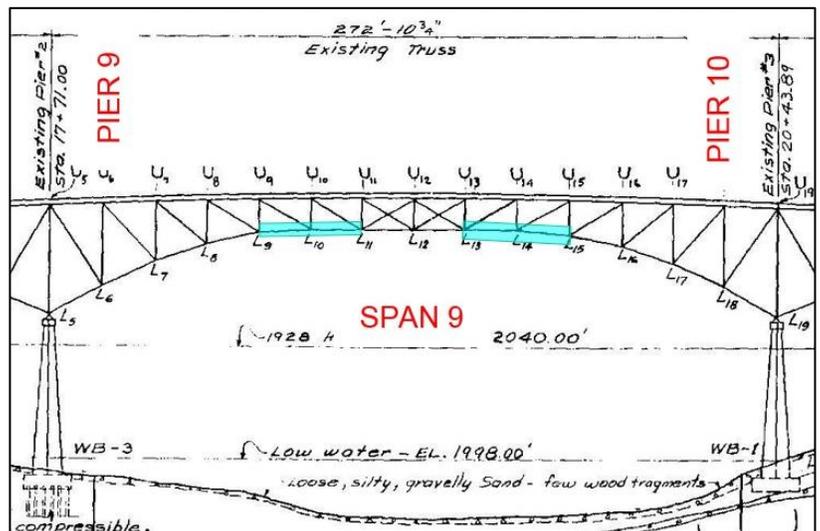
Figure 7 – Bridge member strengthening

The insufficient rating factor of 0.88 for the Type 3-3 Truck Configuration is based upon a legal truck train (Figure 6 below). This configuration shows (2) truck plus trailer configurations (at 75% capacity) in one line separated by 30-feet. This rating configuration is required to be analyzed for continuous structures.

The most economically feasible is Alternative 1. This would include, at a minimum, modifications to Truss Members L9-L10, L10-L11, L13-L14, and L14-L15 on each side of the truss (highlighted in Figure 7). This work would require the following steps:

Prior to any truss strengthening work, it would be recommended to fully clean the bridge and re-inspect to ensure there have been no major conditional changes in truss members.

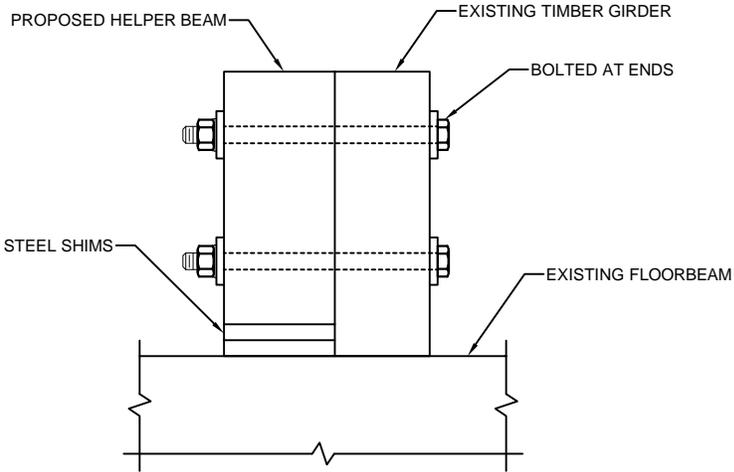
TIMBER GIRDER REPAIR

There are presently 12 timber girders which have splitting. The splitting ranges in length from several feet to full length (19-ft). Girders which have splitting have been yellow-tagged. The Washington State Bridge Inspection Manual (WSBIM) defines this as members with structural defects which do not significantly affect structural capacity. WSBIM recommends inspecting yellow-tagged timbers at least every 12 months.

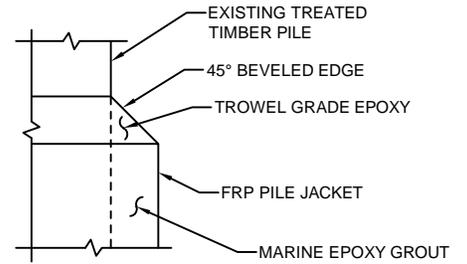
TIMBER PILE REPAIR

The majority of timber piles have checking up to 1-inch wide and up to 5-inch deep. Piling at Piers 7 and 12 nearest to the river have checking up to 2-inch wide and up to 5.5-inch deep (Photo 6). There are currently 12 piles in the bridge that are considered to have the most severe checking.

Piles with deep checking will deteriorate more quickly as the internal portion of the piling is exposed to oxygen, organisms, and moisture. Additionally, the severe checking of piling has the potential to jeopardize the stability of the piles (buckling) if advanced section loss occurs. Also, wide checking could advance into a through split which would significantly reduce pile capacity.

Potential repairs for checking depend on severity and can range from preservative treatment to steel banding to crack filling and then pile jacketing for the most severe cases. FRP pile jackets are suitable for repairing piling that needs an increase in strength, but do not require total replacement. The space between the pile and the jacket is filled with a marine epoxy which completely fills cracks and voids. The FRP pile jacket system protects the pile from the elements and it cuts out oxygen access to the wood, thereby eliminating the potential for decay. Cost estimating in this planning report assumes twelve piles would be repaired with pile jacketing.

Prior to design and installation of permanent repairs, piles should undergo non-destructive testing for decay at multiple locations near ground level. If any decay is found, pile splicing may be required to eliminate any unsound material. A Resistograph machine may be used.

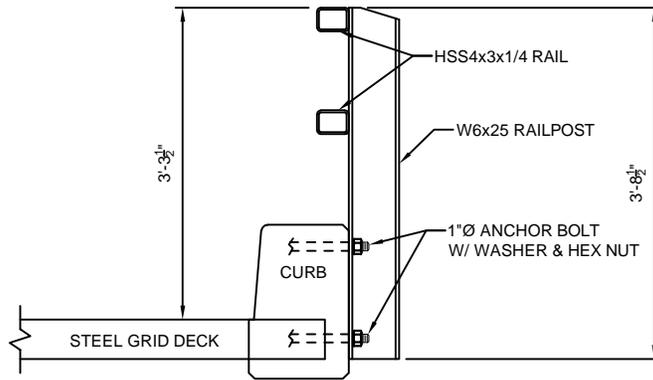
EXISTING RAIL

WEIGHT = 40 LB/FT
